NPDES/MSGP Compliance Inspection Report

Name of Facility: Tenleytown Trash

Facility Location: 6318 Chillum Place NW, Washington, DC 20011

Date of Inspection: September 5, 2018

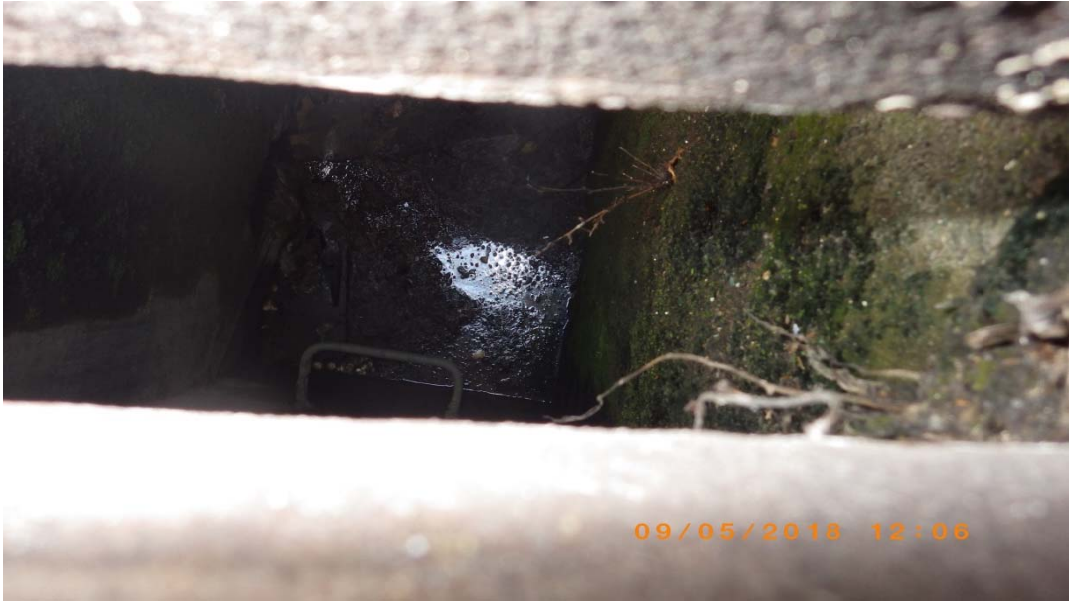
Inspection or Case File Name:		Case Number or Schedule ID:	
Facility Name: Tenleytown Trash		Facility Address: 6318 Chillum Place NW	
Photograph No. 3

Photographer: Robert Burnett			
Inspection Date: September 5, 2018			
Direction:			
Description: Photograph of the water contained within the catch basin shown in Photograph No. 2 showing the water within to be turbid with oil on top.			
Photograph No. 4

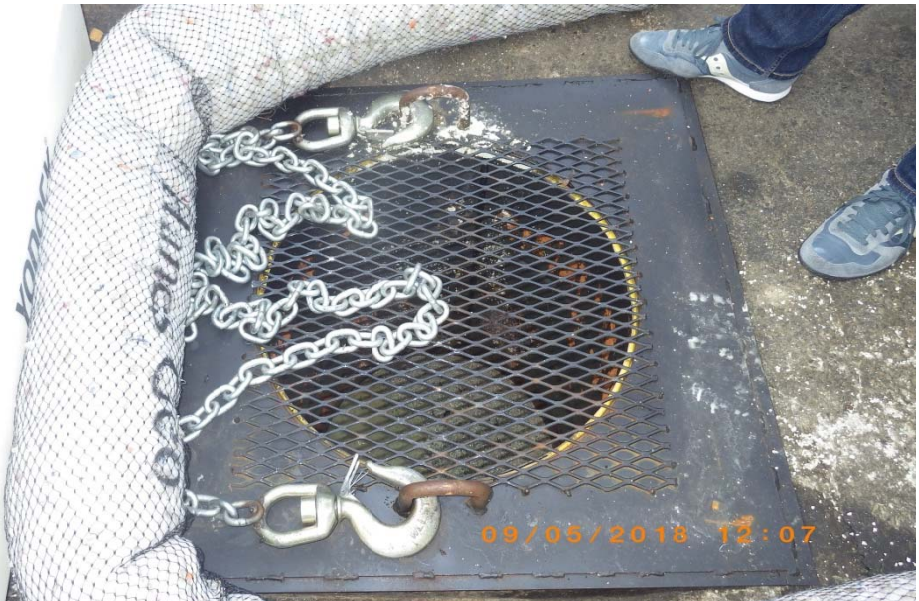
The facility does not have or maintain any BMPs intended to limit the amount of pollutants leaving the site via stormwater, with the exception of a grit trap located in one catch basin behind the facility. The owner stated that the grit trap is emptied on a daily basis, but at the time of inspection it was observed to have sediment in it.

Photographer: Robert Burnett			
Inspection Date: September 5, 2018			
Direction:			
Description: Grit trap located within second catch basin behind Tenleytown Trash maintenance building full of sand and in need of maintenance.

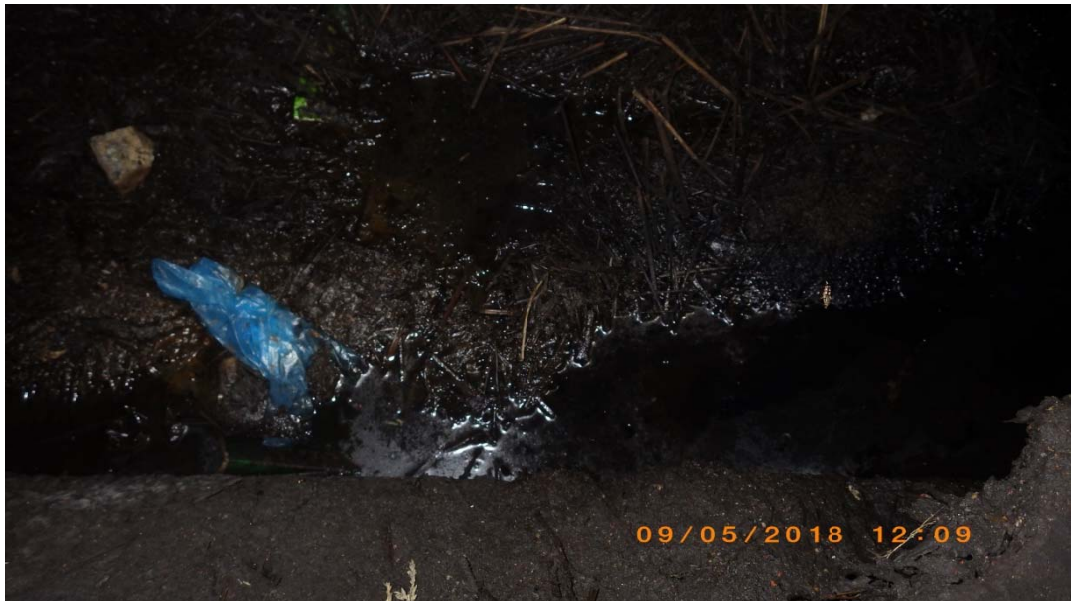
Photographer:			
Robert Burnett			
Inspection Date:			
September 5, 2018			
Direction:			
Description:			
Photograph of the water within the curb inlet shown in Photograph No. 5 showing oil and debris in the inlet.

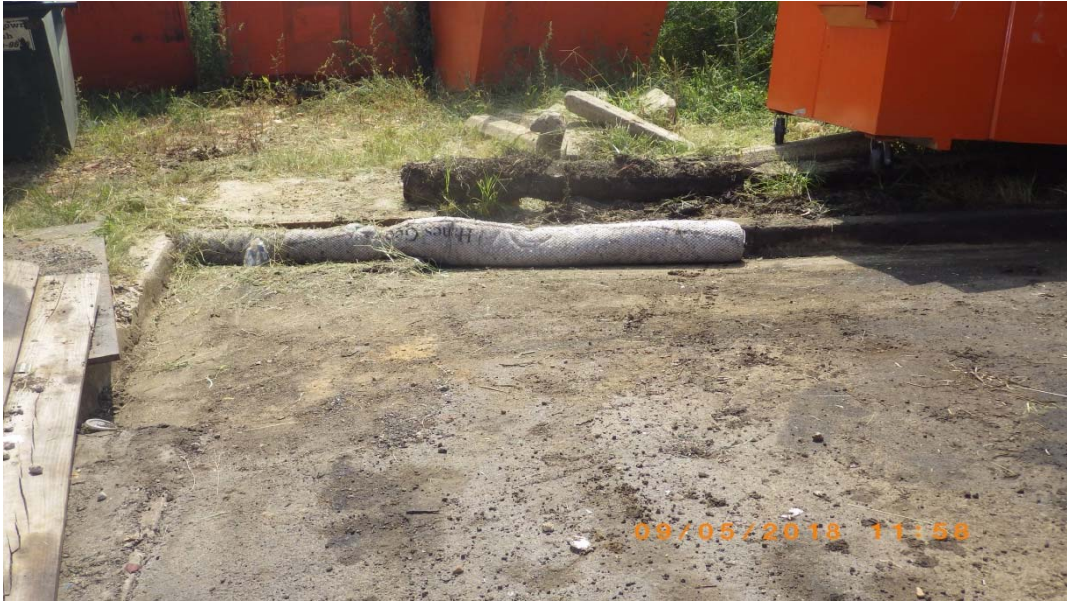
Inspection or Case File Name:		Case Number or Schedule ID:	
Facility Name: Tenleytown Trash		Facility Address: 6318 Chillum Place NW	
Photograph No. 7

Photographer:			
Robert Burnett			
Inspection Date:			
September 5, 2018			
Direction:			
South			
Description:			
Curb inlet in the southeast corner of the Tenleytown Trash facility adjacent to the trash dumpsters at the site. Sediment accumulations and oil stains can be seen on the surface near the inlet.			
Photograph No. 8

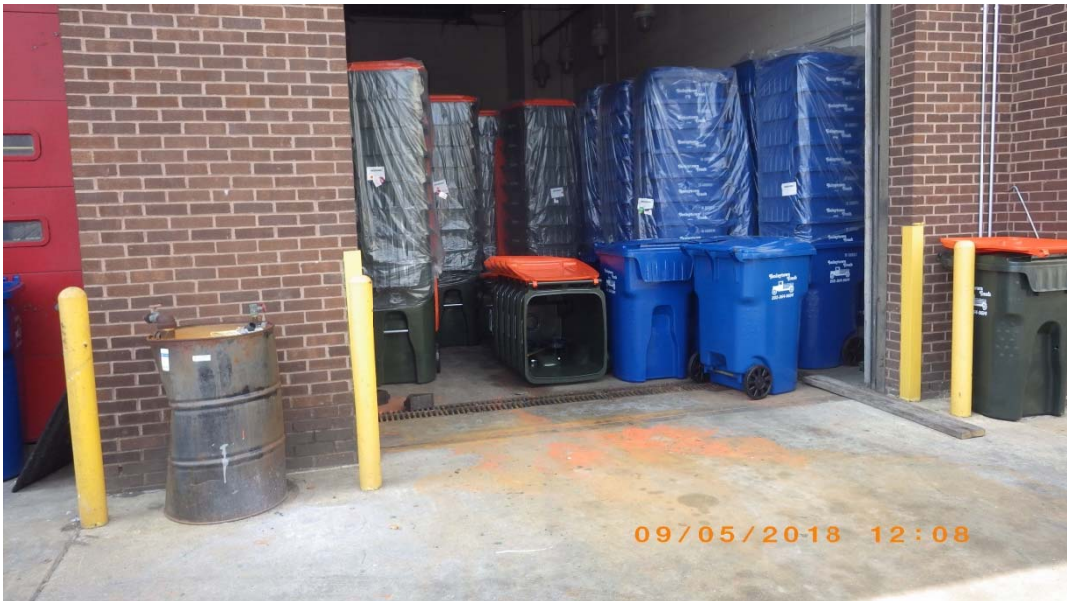
Photographer:			
Robert Burnett			
Inspection Date:			
September 5, 2018			
Direction:			
Description:			
Paint staining at one of the maintenance bays of the facility outside of the building and not collected by the internal trench drain.

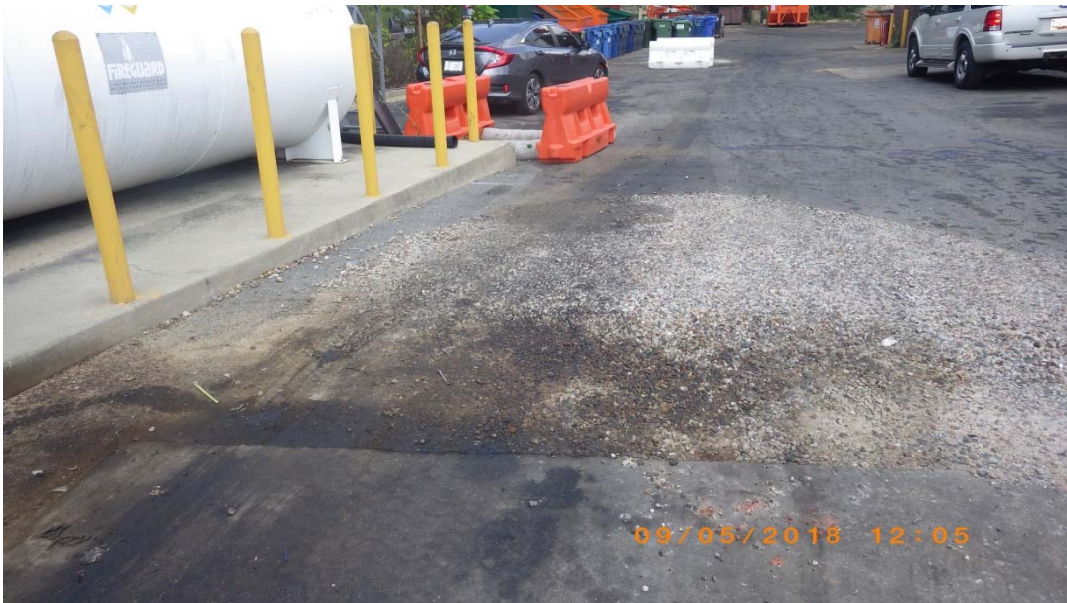
Inspection or Case File Name:		Case Number or Schedule ID:	
Facility Name: Tenleytown Trash		Facility Address: 6318 Chillum Place NW	
Photograph No. 13

Photographer:			
Robert Burnett			
Inspection Date:			
September 5, 2018			
Direction:			
North			
Description:			
Heavy oil staining on the asphalt surface adjacent to the diesel dispenser and the nearby catch basin.			
Photograph No. 14			
Photographer:

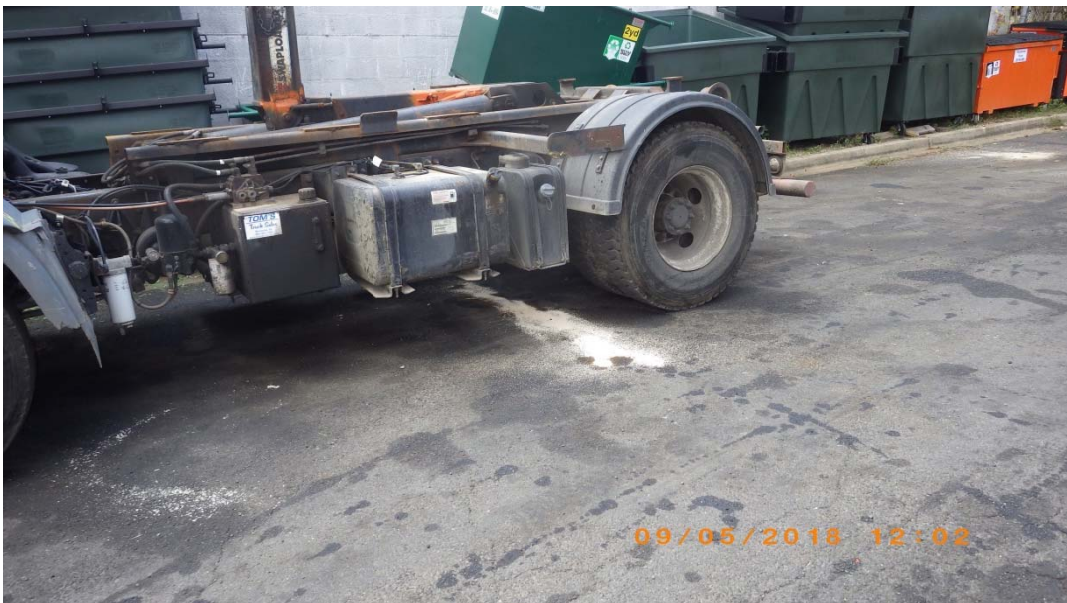
Robert Burnett			
Inspection Date:			
September 5, 2018			
Direction:			
Description:			
Out of service trash truck at the facility leaking oil onto the surface.

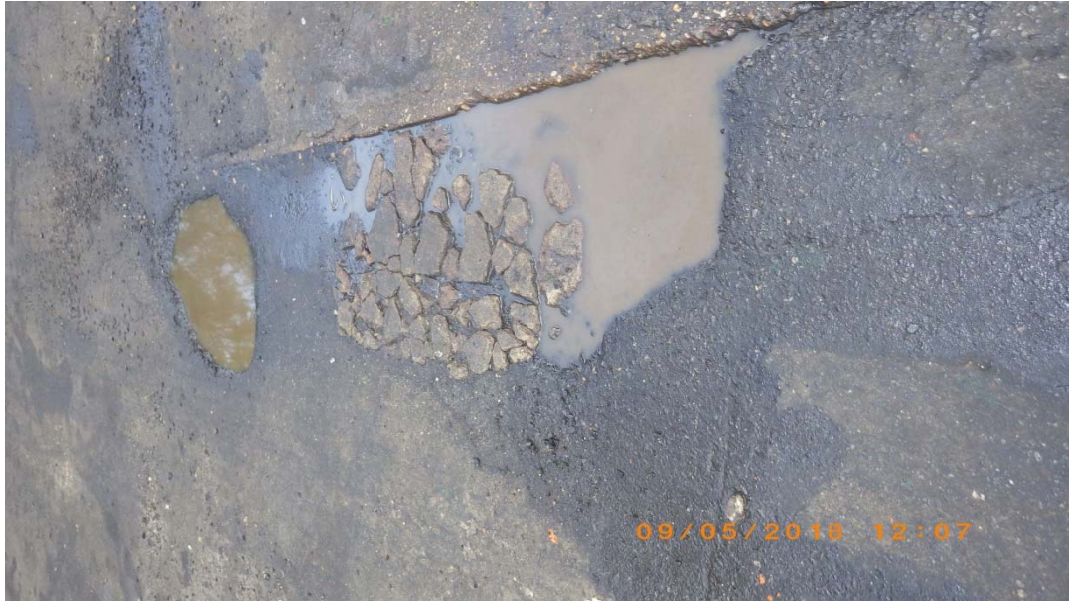
Inspection or Case File Name:		Case Number or Schedule ID:	
Facility Name: Tenleytown Trash		Facility Address: 6318 Chillum Place NW	
Photograph No. 15

Photographer:			
Robert Burnett			
Inspection Date:			
September 5, 2018			
Direction:			
Description:	An accumulation of trash fluid that has leaked from the compactor of a trash truck.		
Photograph No. 16

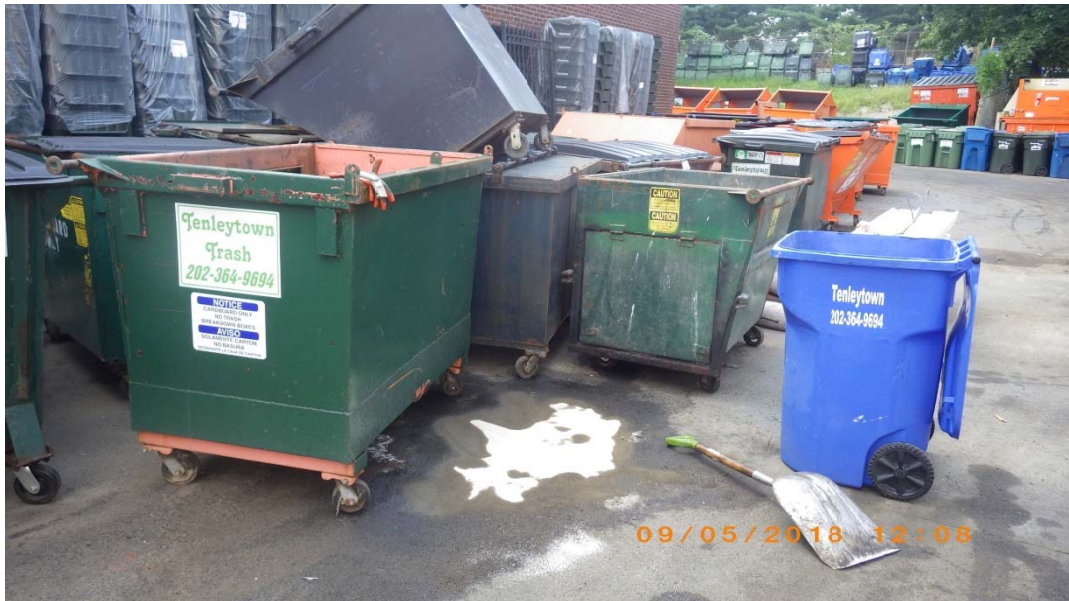
The trash bin storage areas at the site were in good condition, with no raw metal or unfinished materials observed stored outside. The roll-off dumpsters awaiting deployment to sites were rusted in areas and mild rust staining was observed on the asphalt surface around them as well as mounds of quick dry material that had not been cleaned up from previous releases (Photograph No. 16).

Photographer:			
Robert Burnett			
Inspection Date:			
September 5, 2018			
Direction:	West		
Description:	Rusted trash dumpsters and a mound of quick dry material that was used to address a spill but was not cleaned up following absorption.

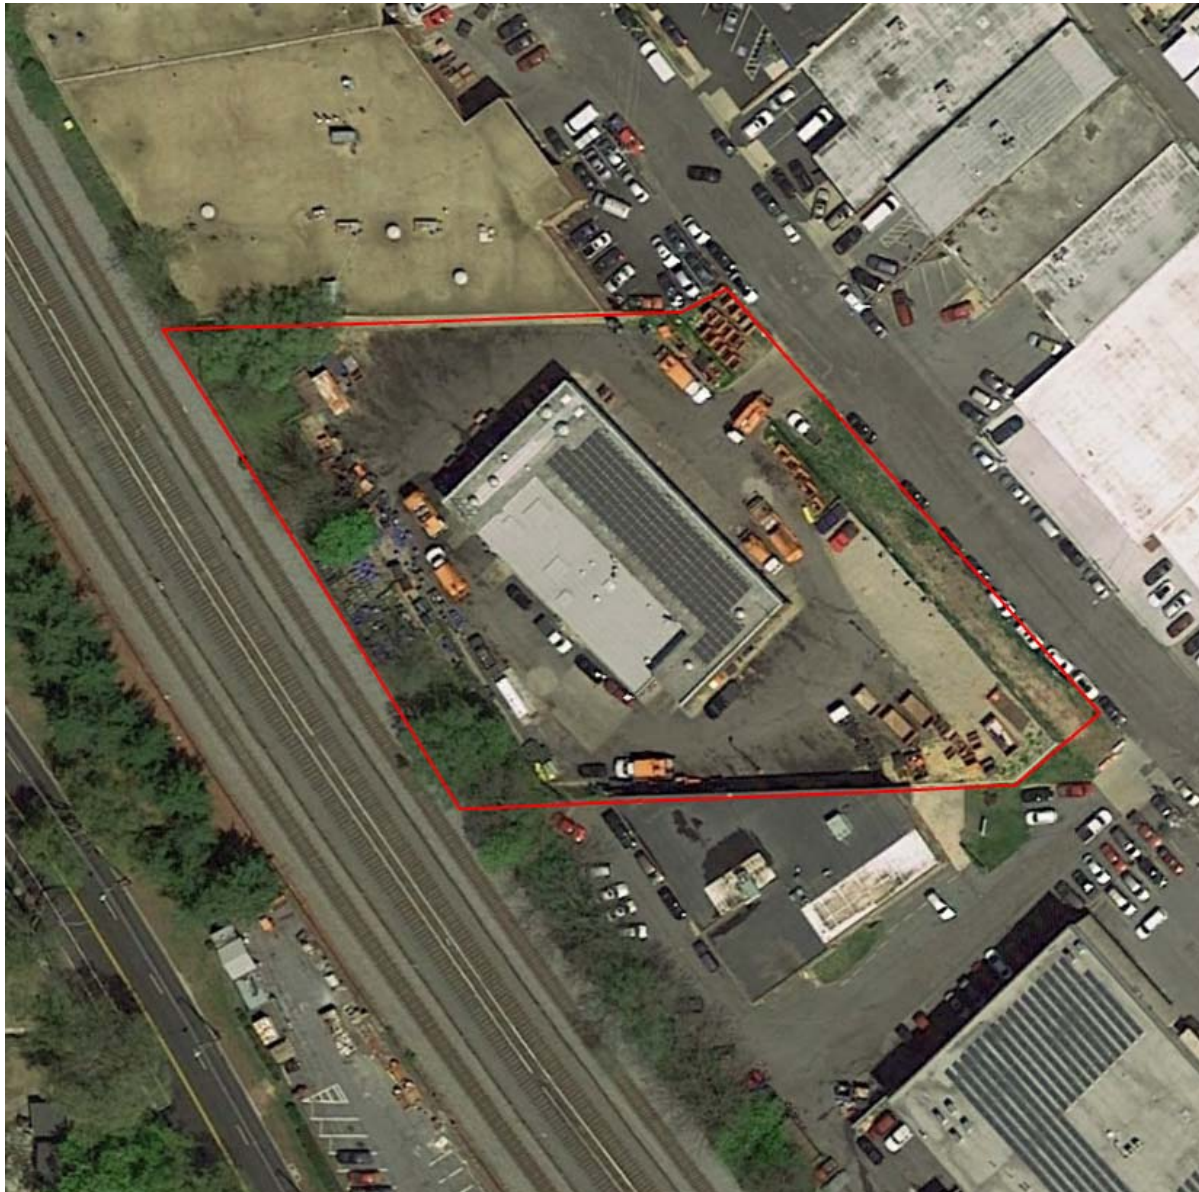
Figure 1: An aerial photograph of the Tenleytown Trash facility located at 6318 Chillum Place NW, Washington, DC.
